Water ingress into Main engine lube oil sump tank.

CL-04/2016

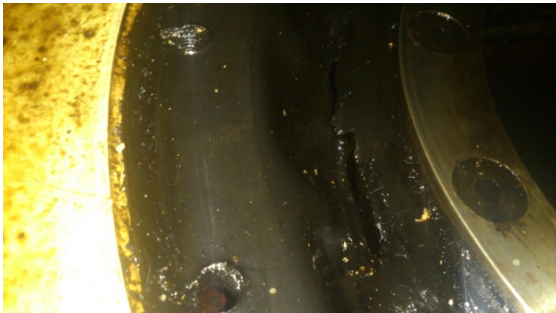
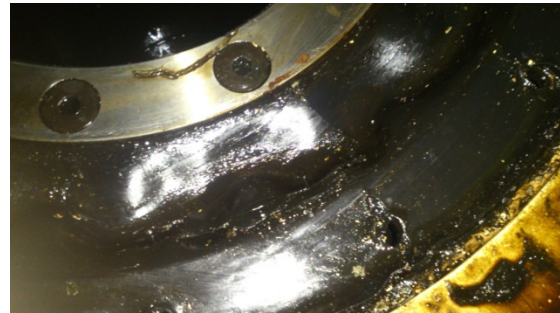
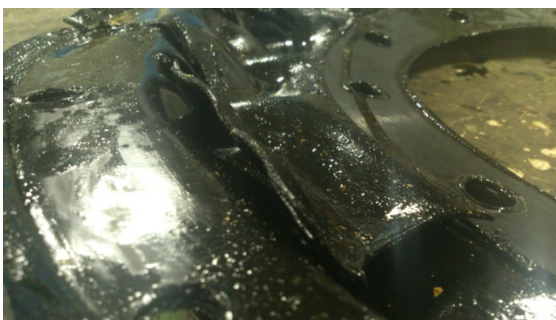
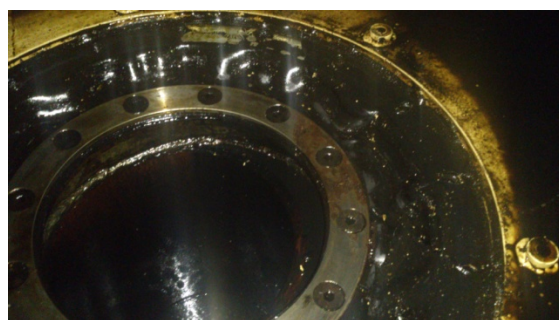
The main engine circulating oil system was heavily contaminated by water during the port stay. The source of water ingress into lube oil system was damaged water hose of purifier. Around ten tons of water, which accumulated on the bilge deck under the main engine, was lost through that hose.

The series of events, such as damaged water hose, defective water level switch in bilge well under main engine flywheel, and damaged rubber diaphragms between the main engine crankcase and the sump tank, caused serious contamination of circulating oil by water. As a result, the vessel could not leave the port until the problem was fixed. The main engine lube oil outlets rubber diaphragms were replaced according to Maker's recommendations, lube oil in sump tank was exchanged by fresh one, and the functionality of level switch was restored.

- Working condition of level switches in the ER bilge wells was not checked regularly;
- Condition of ME LO outlets rubber diaphragms was not checked since the delivery of the vessel. The total amount of engine running hours is 101 156, therefore the rubber diaphragms had to be changed three times according to Maker's advice to do it after each 32 000 hours of operation.

- The crew members were not adequately familiar with engine construction and Maker's recommendations.

Service letters, related to MAN engines, are situated on the website of MAN or could be requested from the technical department of company. The recommendations about the accident described above can be found in the service letter SL08-492.

To avoid operational losses (demurrage, expenses related to lube oil cost) the following actions must be considered as vital:

- Weekly inspection and testing of level alarms in the engine room bilge wells;
- Inclusion of all necessary inspections into planned maintenance system which has to be implemented onboard of each vessel;
- Regular training for engine room staff.
